HARVARD EXCAVATIONS
AT SAMARIA

HARVARD EXCAVATIONS AT SAMARIA

1908 — 1910

VOLUME II. PLANS AND PLATES

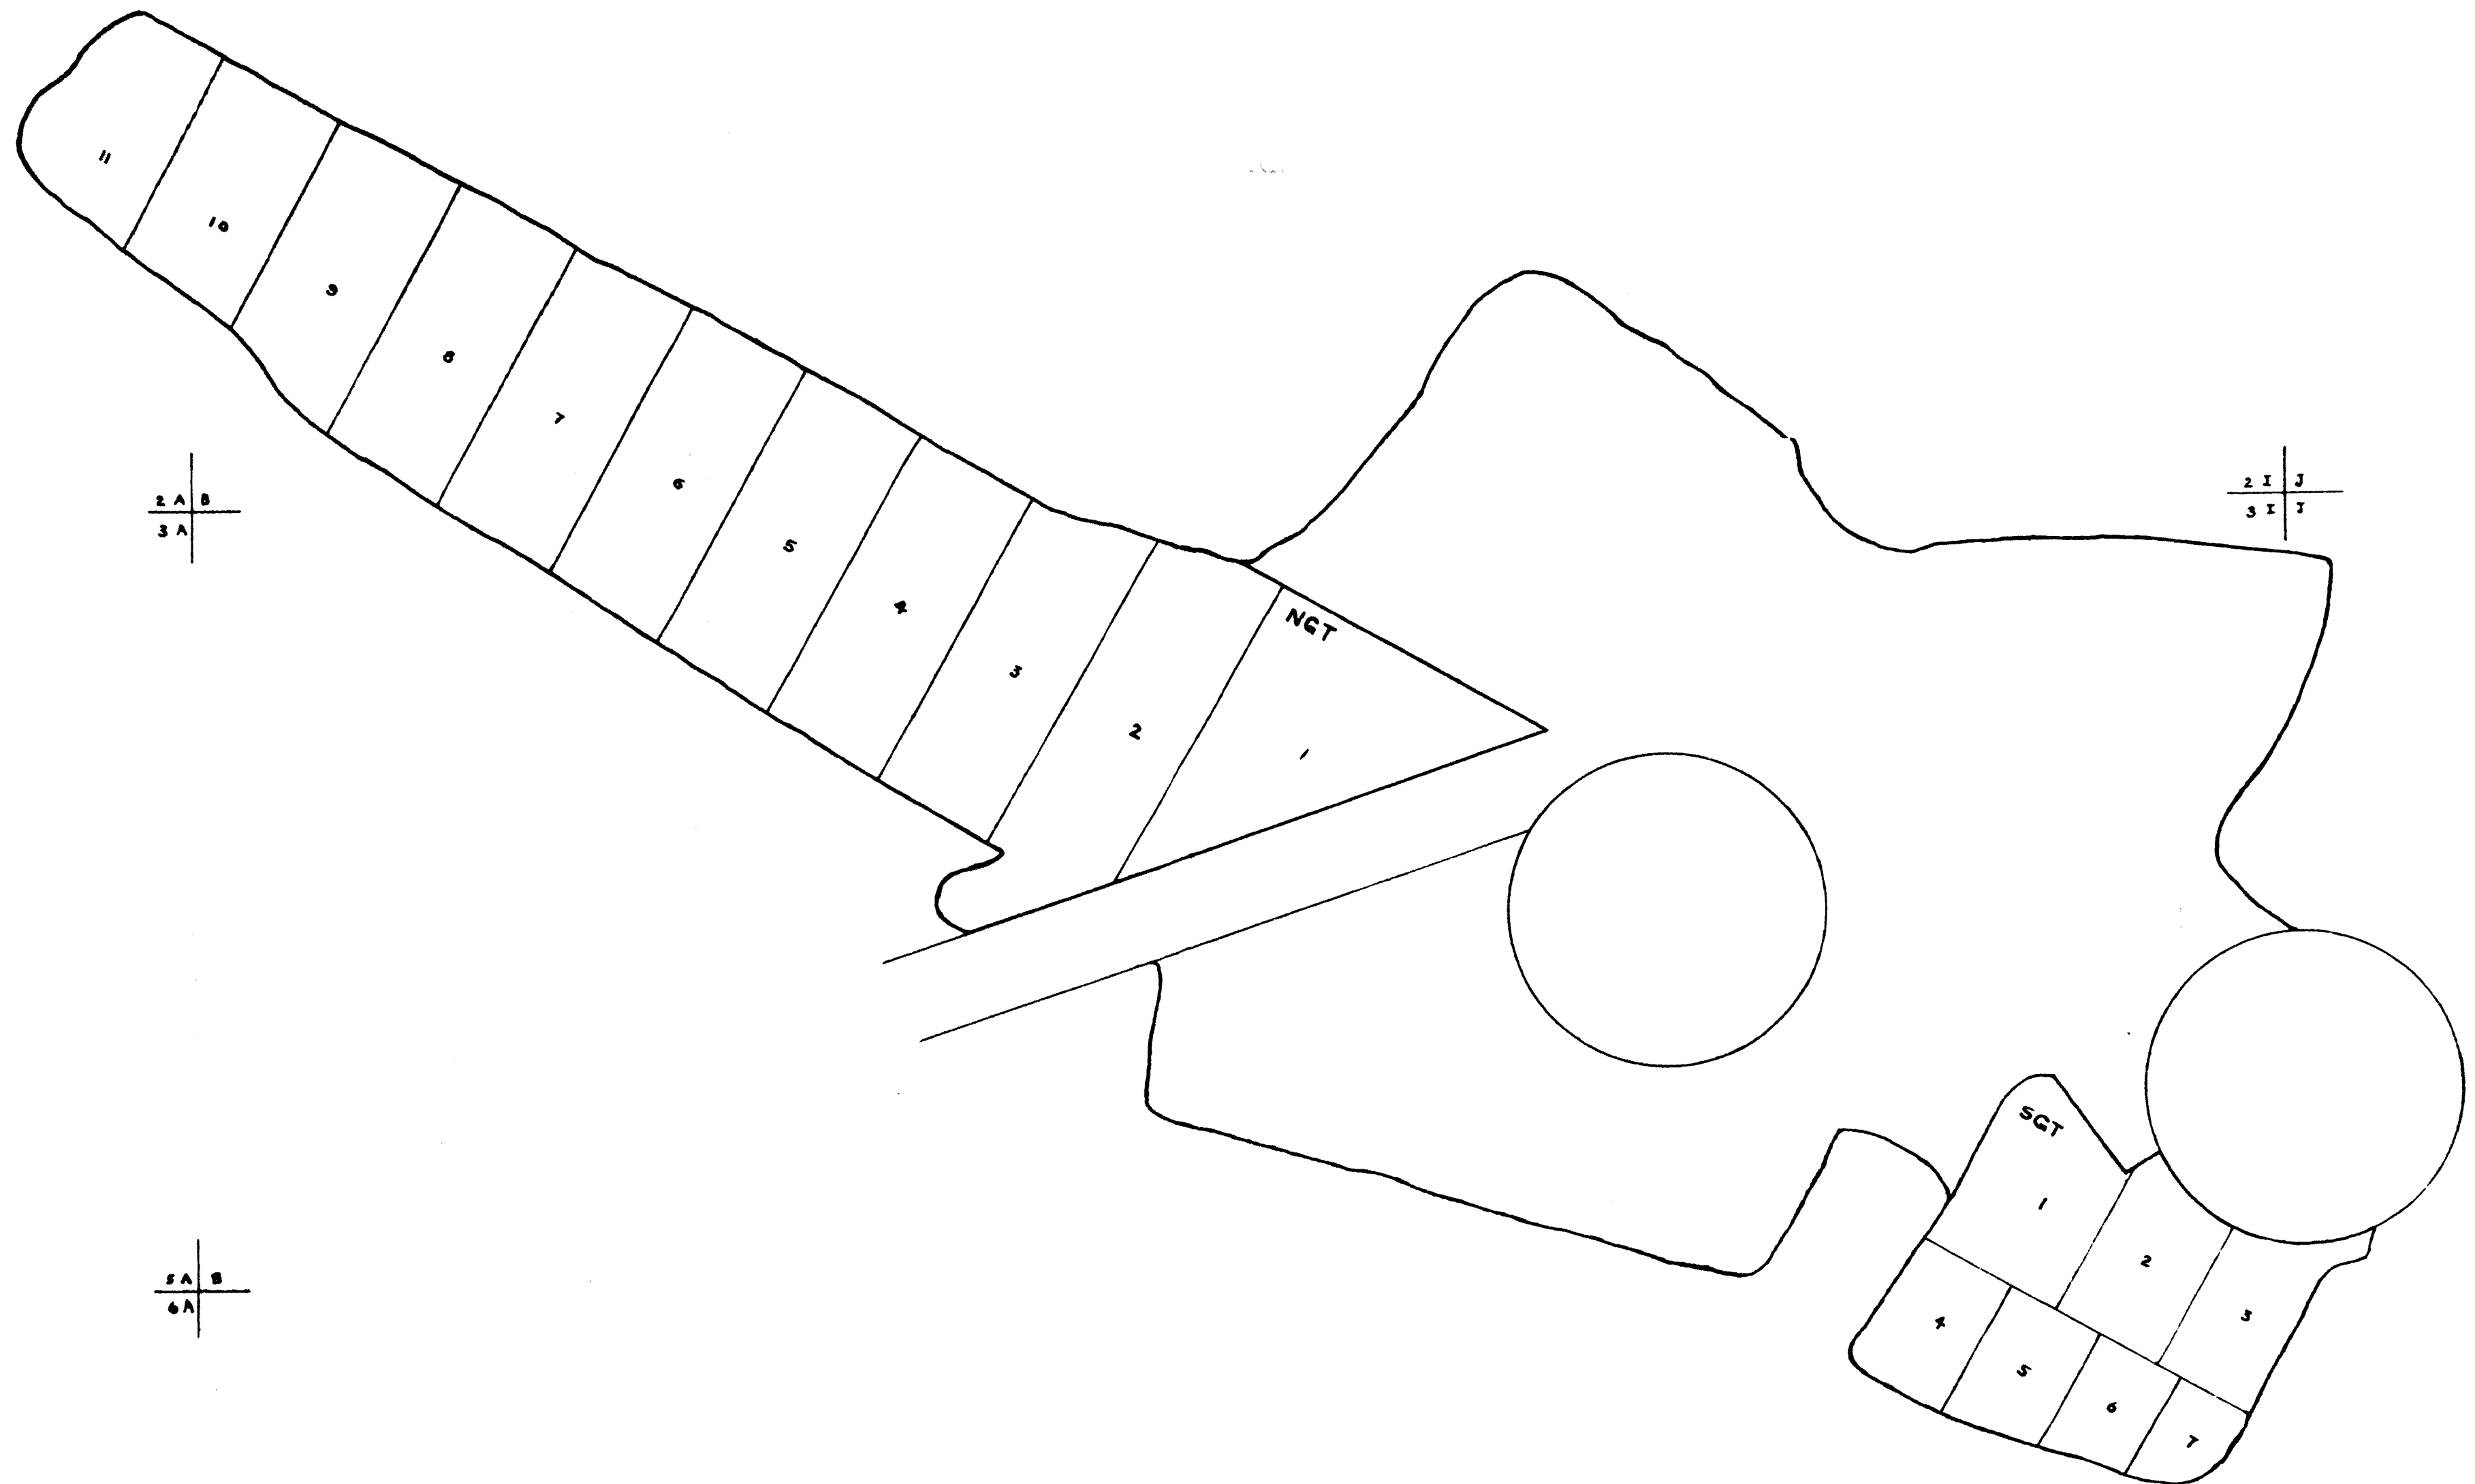
PLAN 10

SAMARIA: WEST GATE

GENERAL PLAN

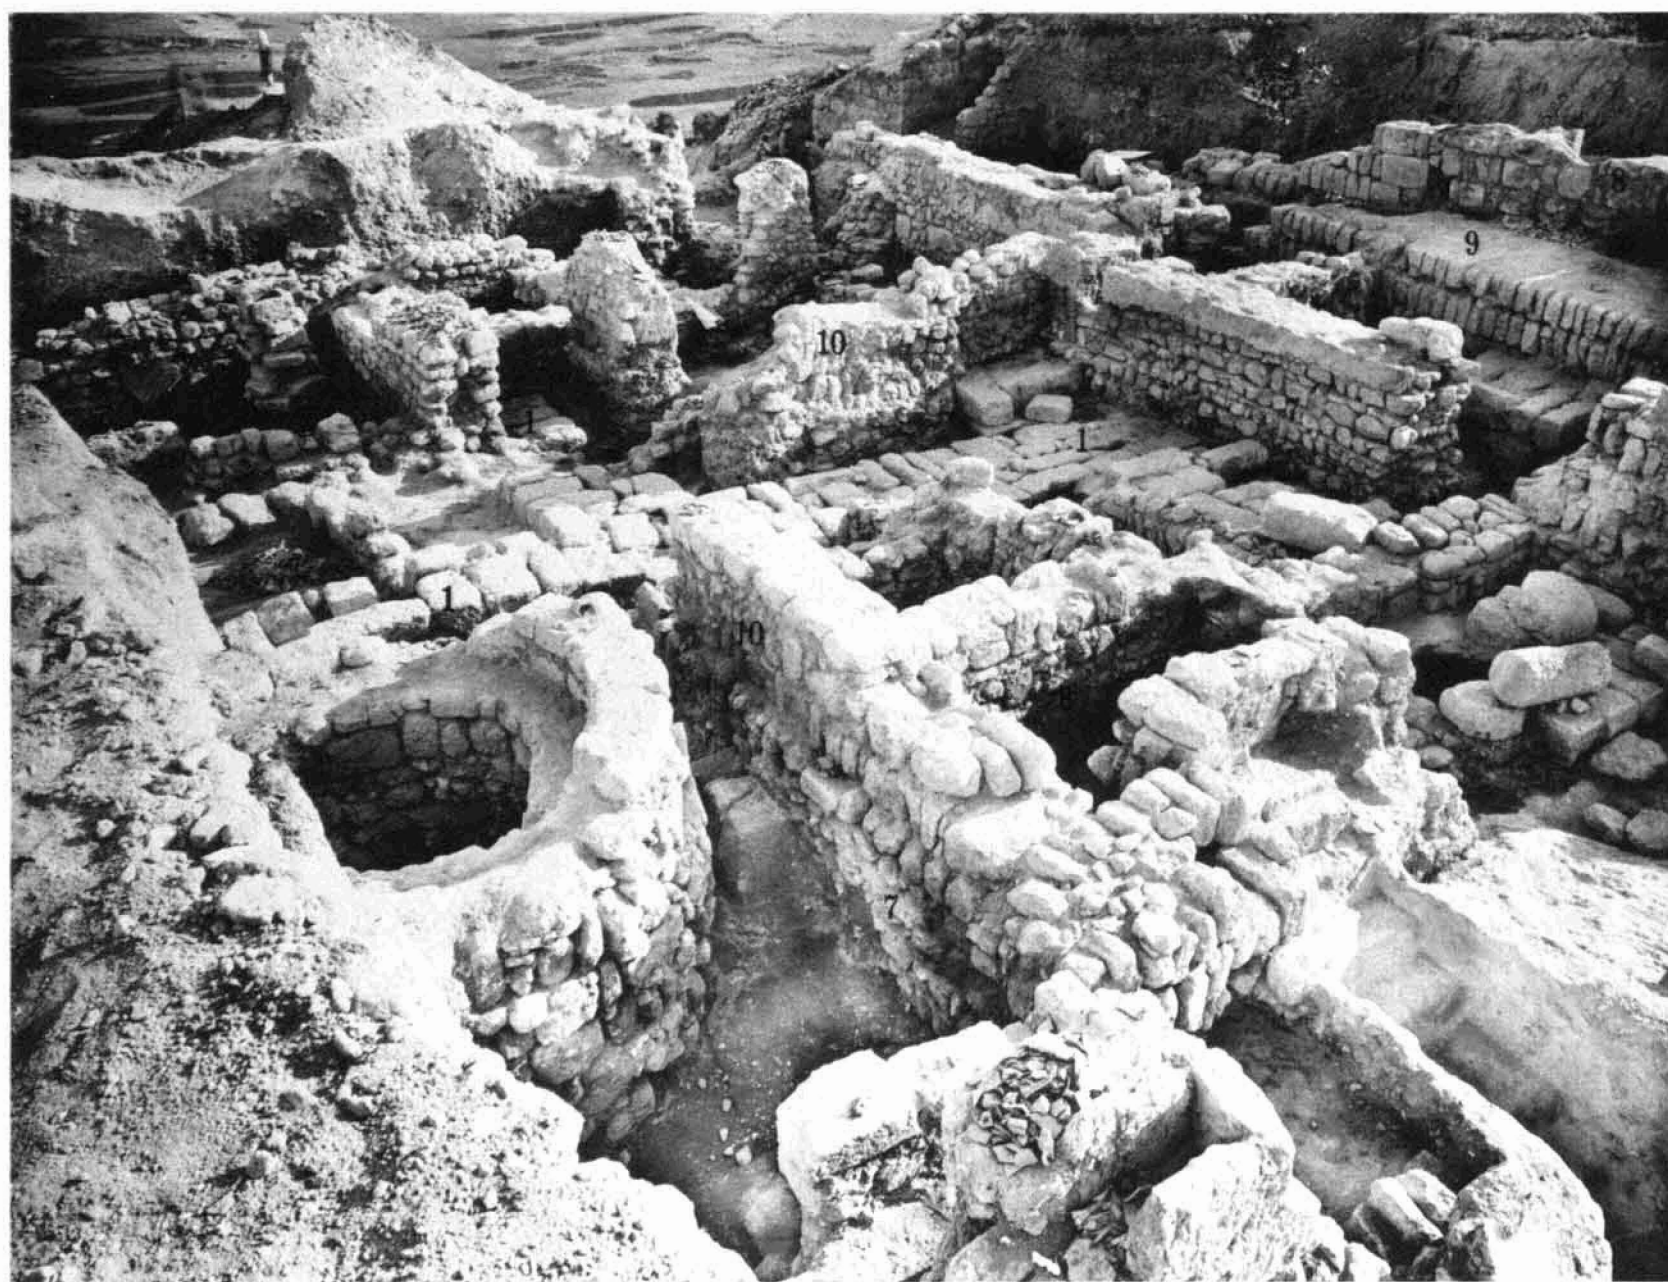
a. STRIP I CLEARED TO MOSAIC LEVEL, LOOKING N. N. E. JUNE 7, 1909.

1. a. Hill of Samaria seen from the south. April 25, 1908.¹
b. Town of Sebaste seen from the south. April 25, 1908.
2. a. Strip 1 cleared to mosaic level, looking north-northeast. June 7, 1909.

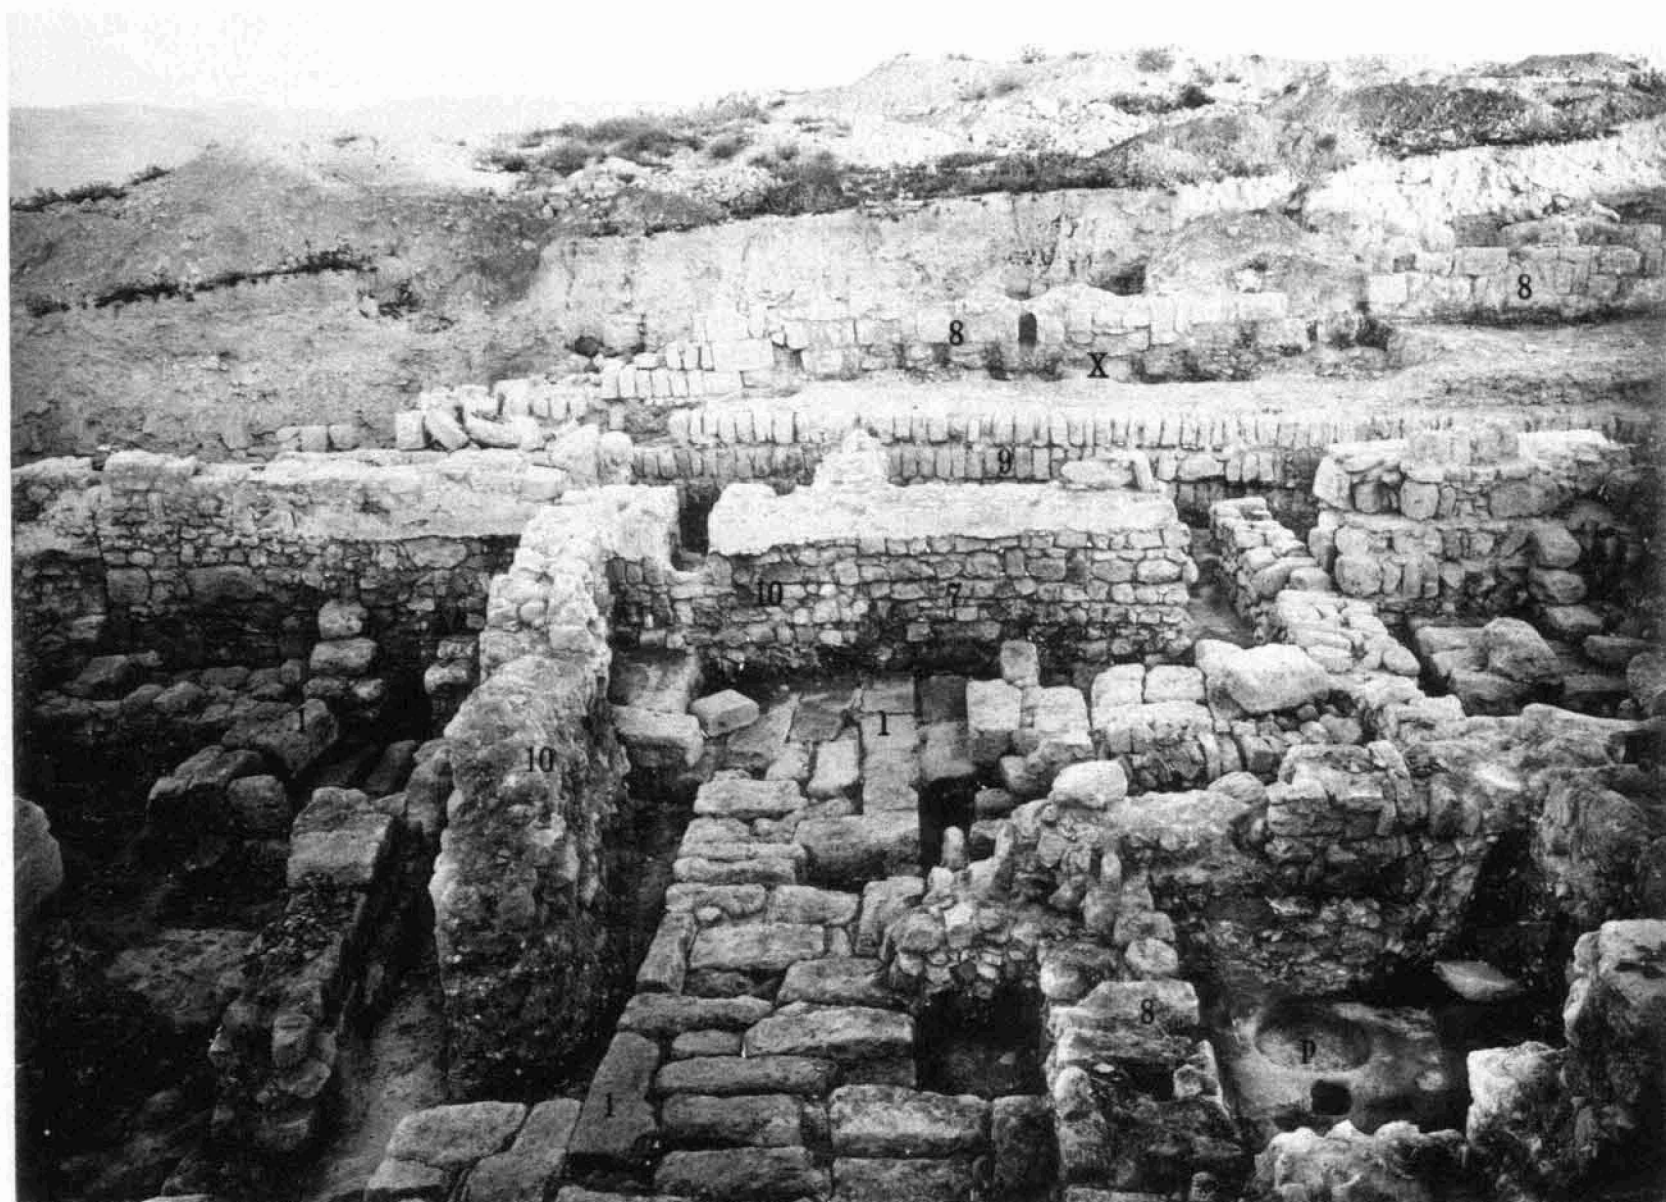
b. STRIP I CLEARED TO ROCK, LOOKING S. S. W. JUNE 24, 1909.

b. Strip 1 cleared to rock, looking south-southwest. June 24, 1909.
3. a. Strip 1, middle, cleared to rock, looking west. June 25, 1909.
b. Strip 1 IV 8, south wall, Israelite foundations, looking east. July 1, 1909.

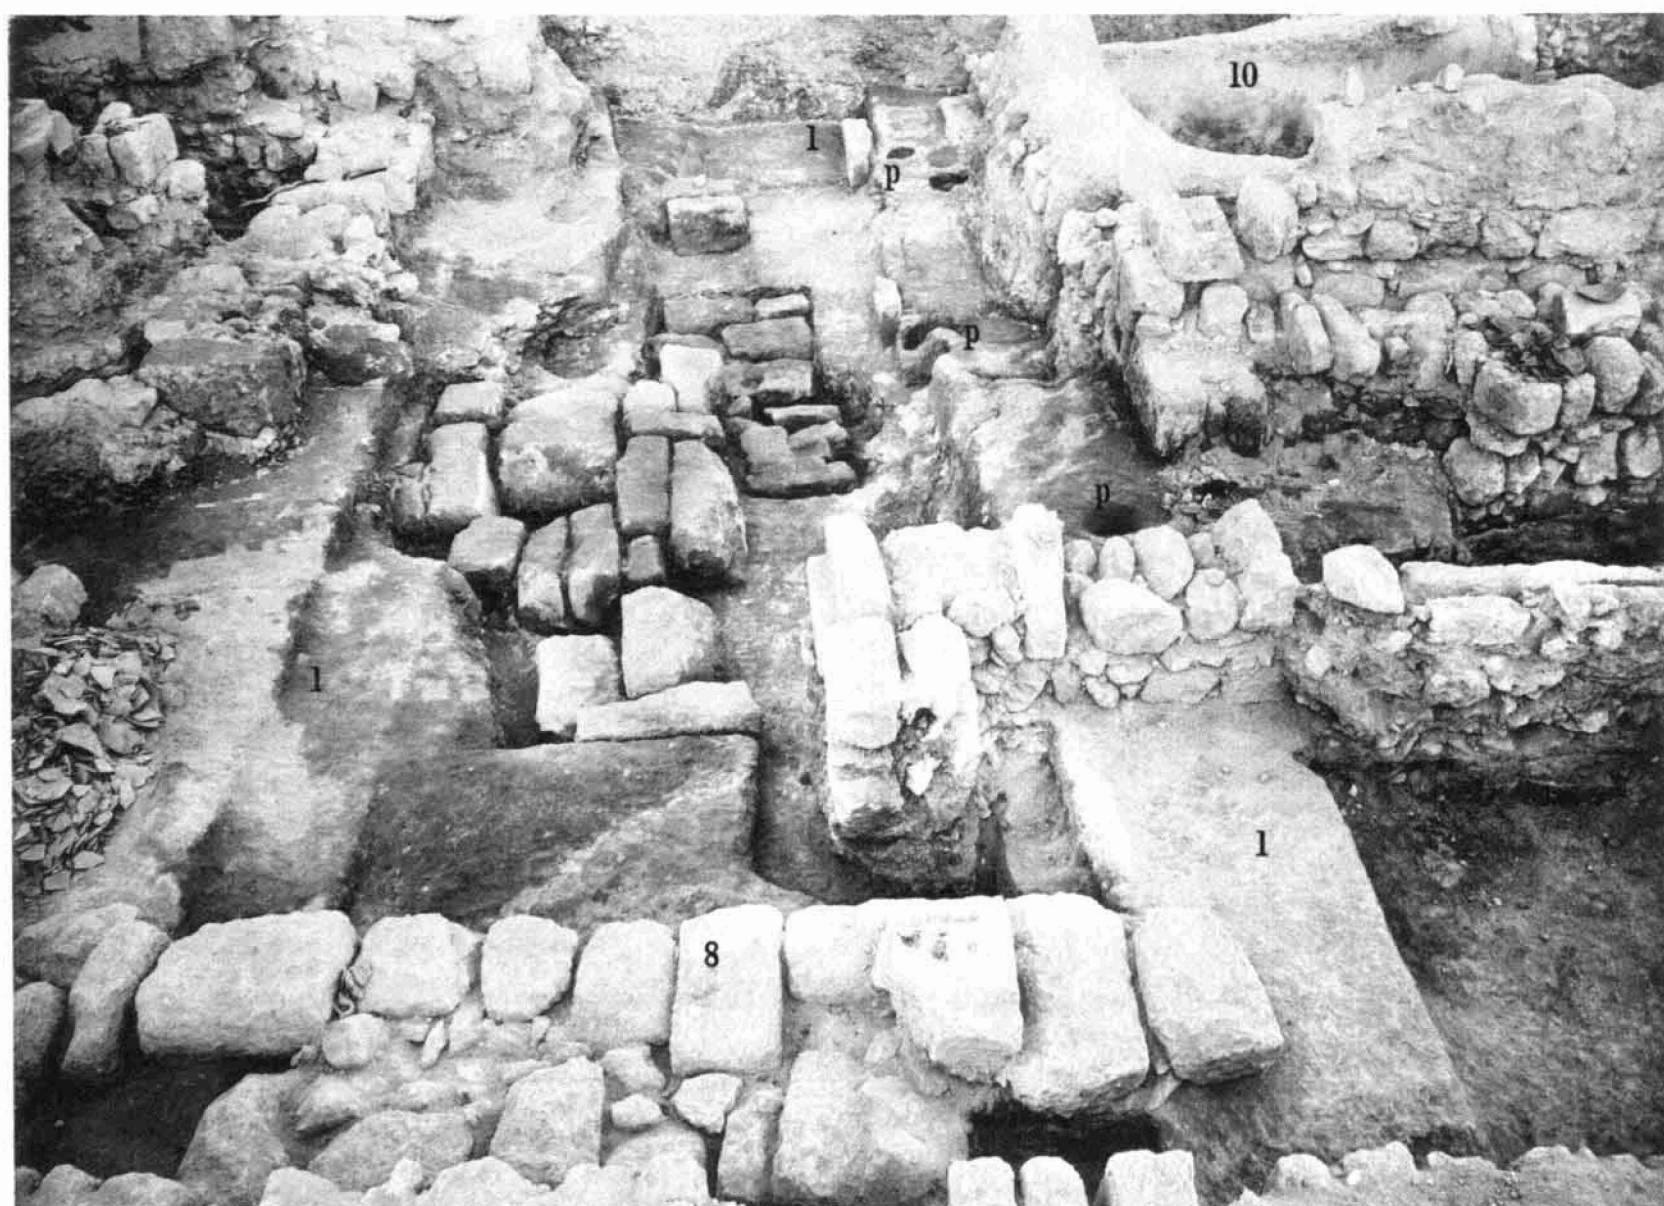
a. STRIP I, MIDDLE, CLEARED TO ROCK, LOOKING W. JUNE 25, 1909.

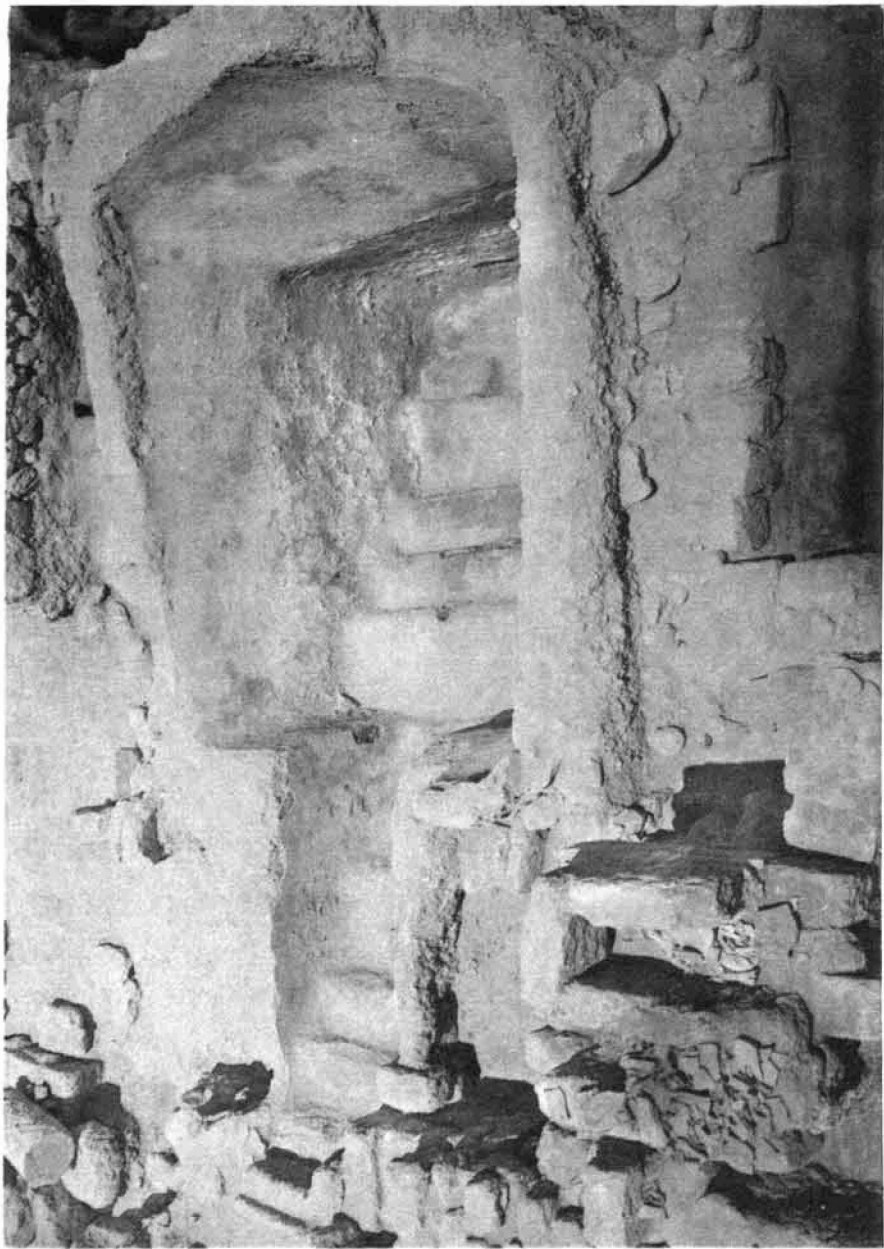
b. STRIP I IV 8, SOUTH WALL, ISRAELITE FOUNDATIONS, LOOKING E. JULY 1, 1909.

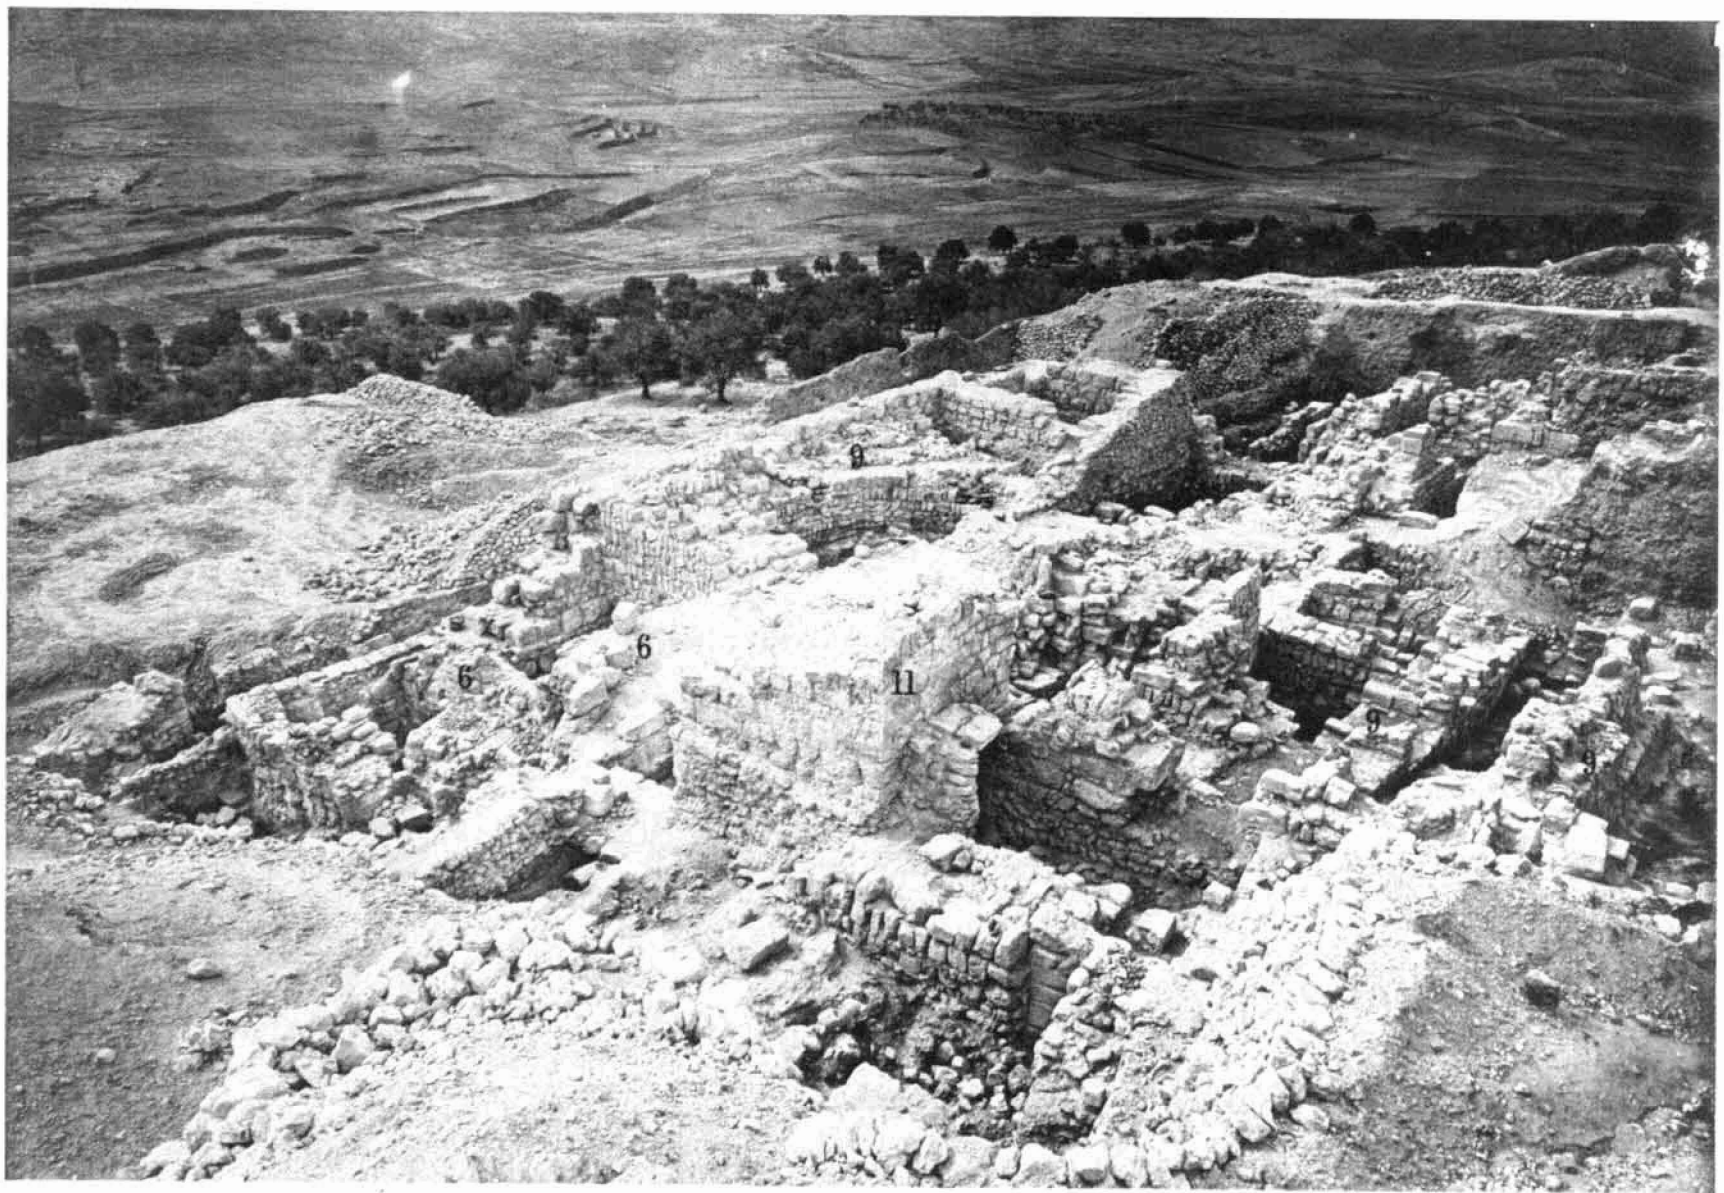
a. STRIP 2 III 26-47, PREHERODIAN FLOOR, LOOKING N. E. JULY 30, 1909.

d. Strip 1 IV 8, south wall, looking west. July 7, 1909. Cf. Pl. 3 b.
5. a. Strip 2 III 26-47, Preherodian floor, looking northeast. July 30, 1909.
b. Strip 2, southern part, cleared to rock, leaving Roman walls standing on debris, looking southwest. Oct. 14, 1909.

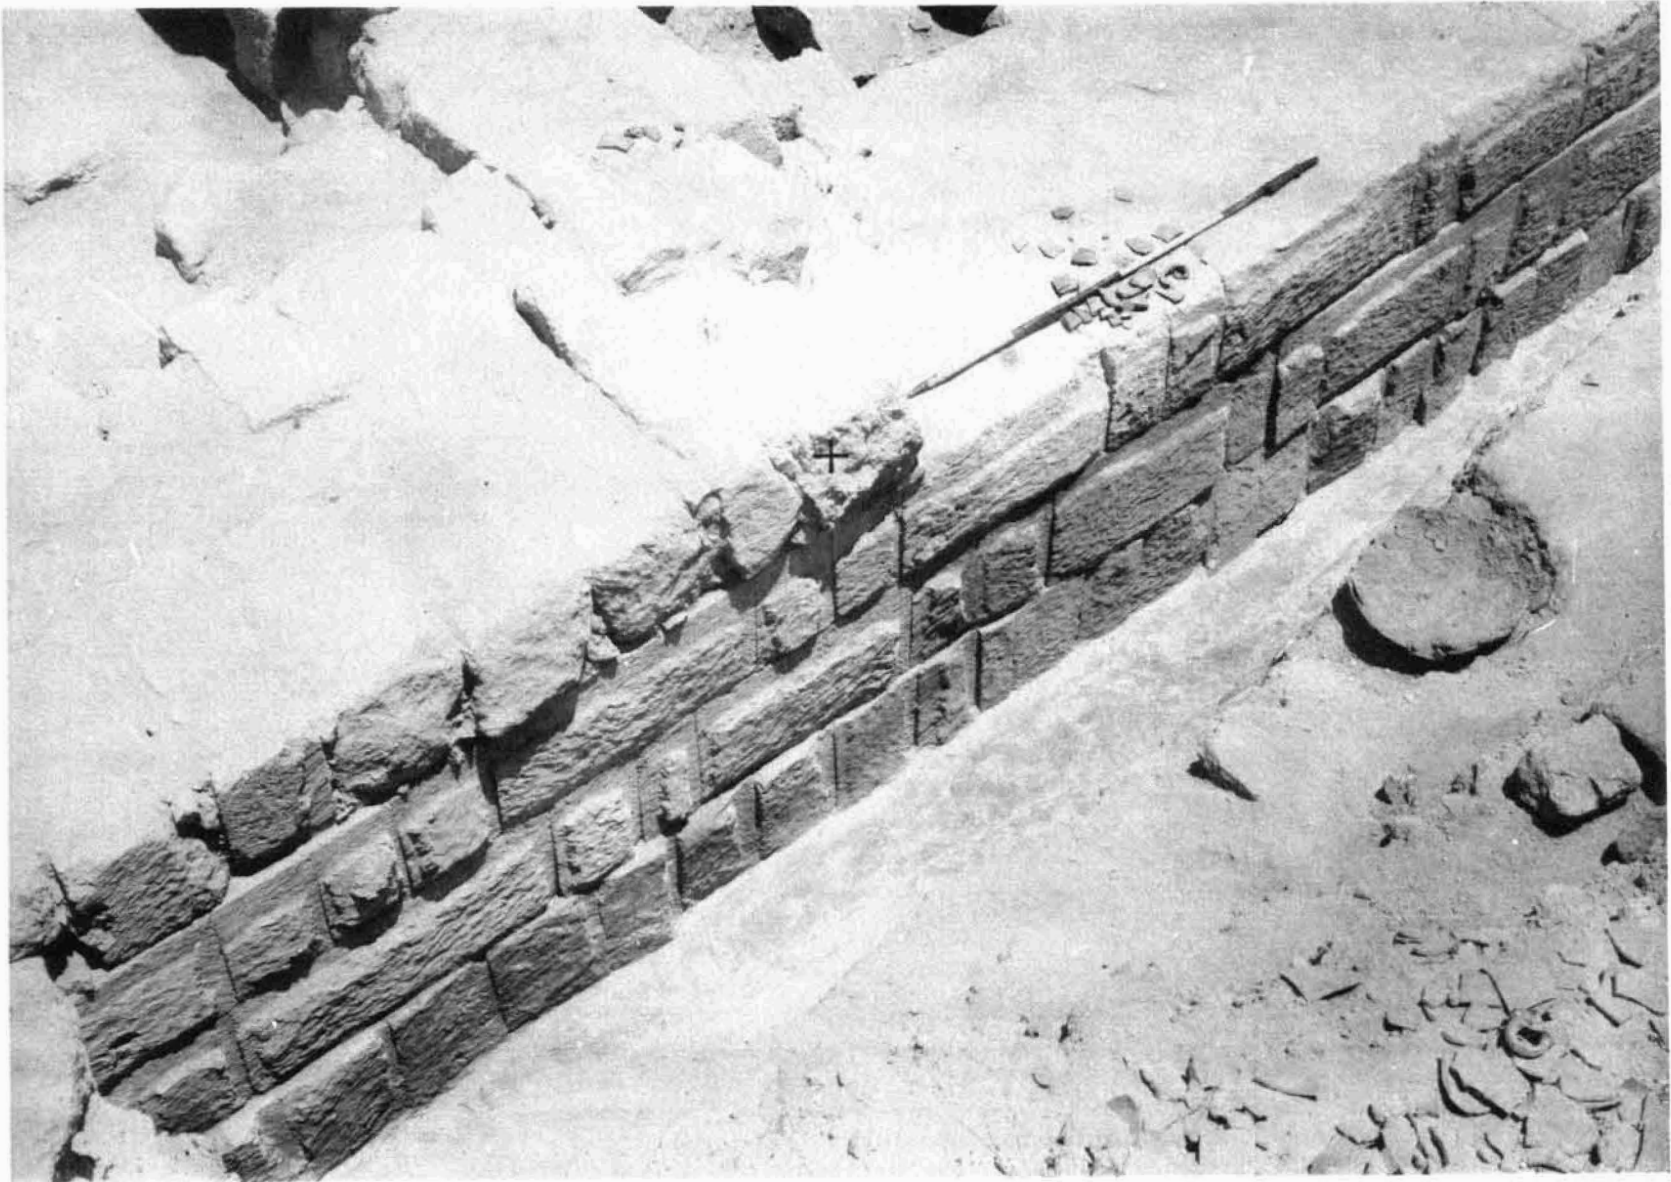
a. STRIP 3. AHAB MASONRY, LOOKING N. E., DOWN. JULY 8, 1910. +, LATER WALL.

- c. Strips 3 and 5, cleared to rock, looking east. July 8, 1910.
- 27. a. Strip 3, Ahab masonry, looking northeast, down. July 8, 1910.
- b. Strip 3, tool marks on Ahab masonry, looking north, down. July 8, 1910.

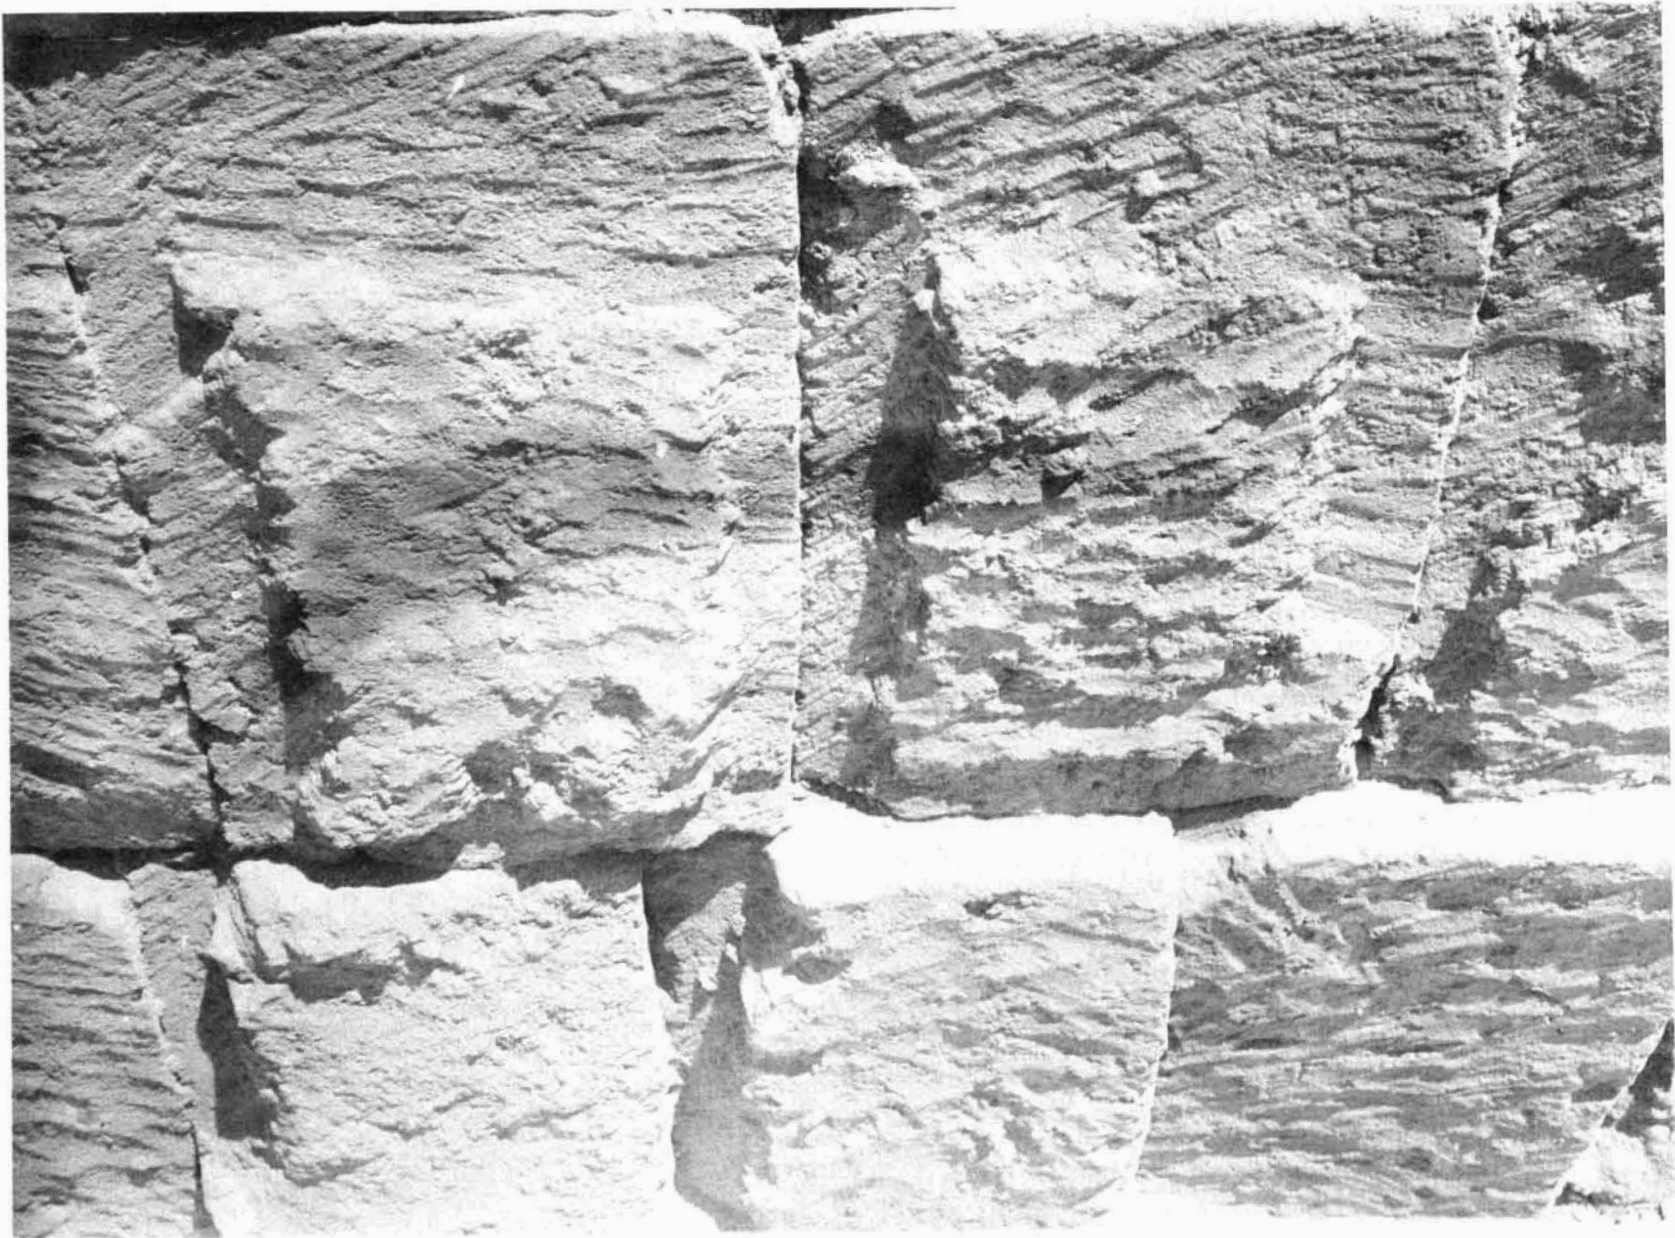
b. STRIP 3, TOOL MARKS OF AHAB MASONRY, LOOKING N., DOWN. JULY 8, 1910.

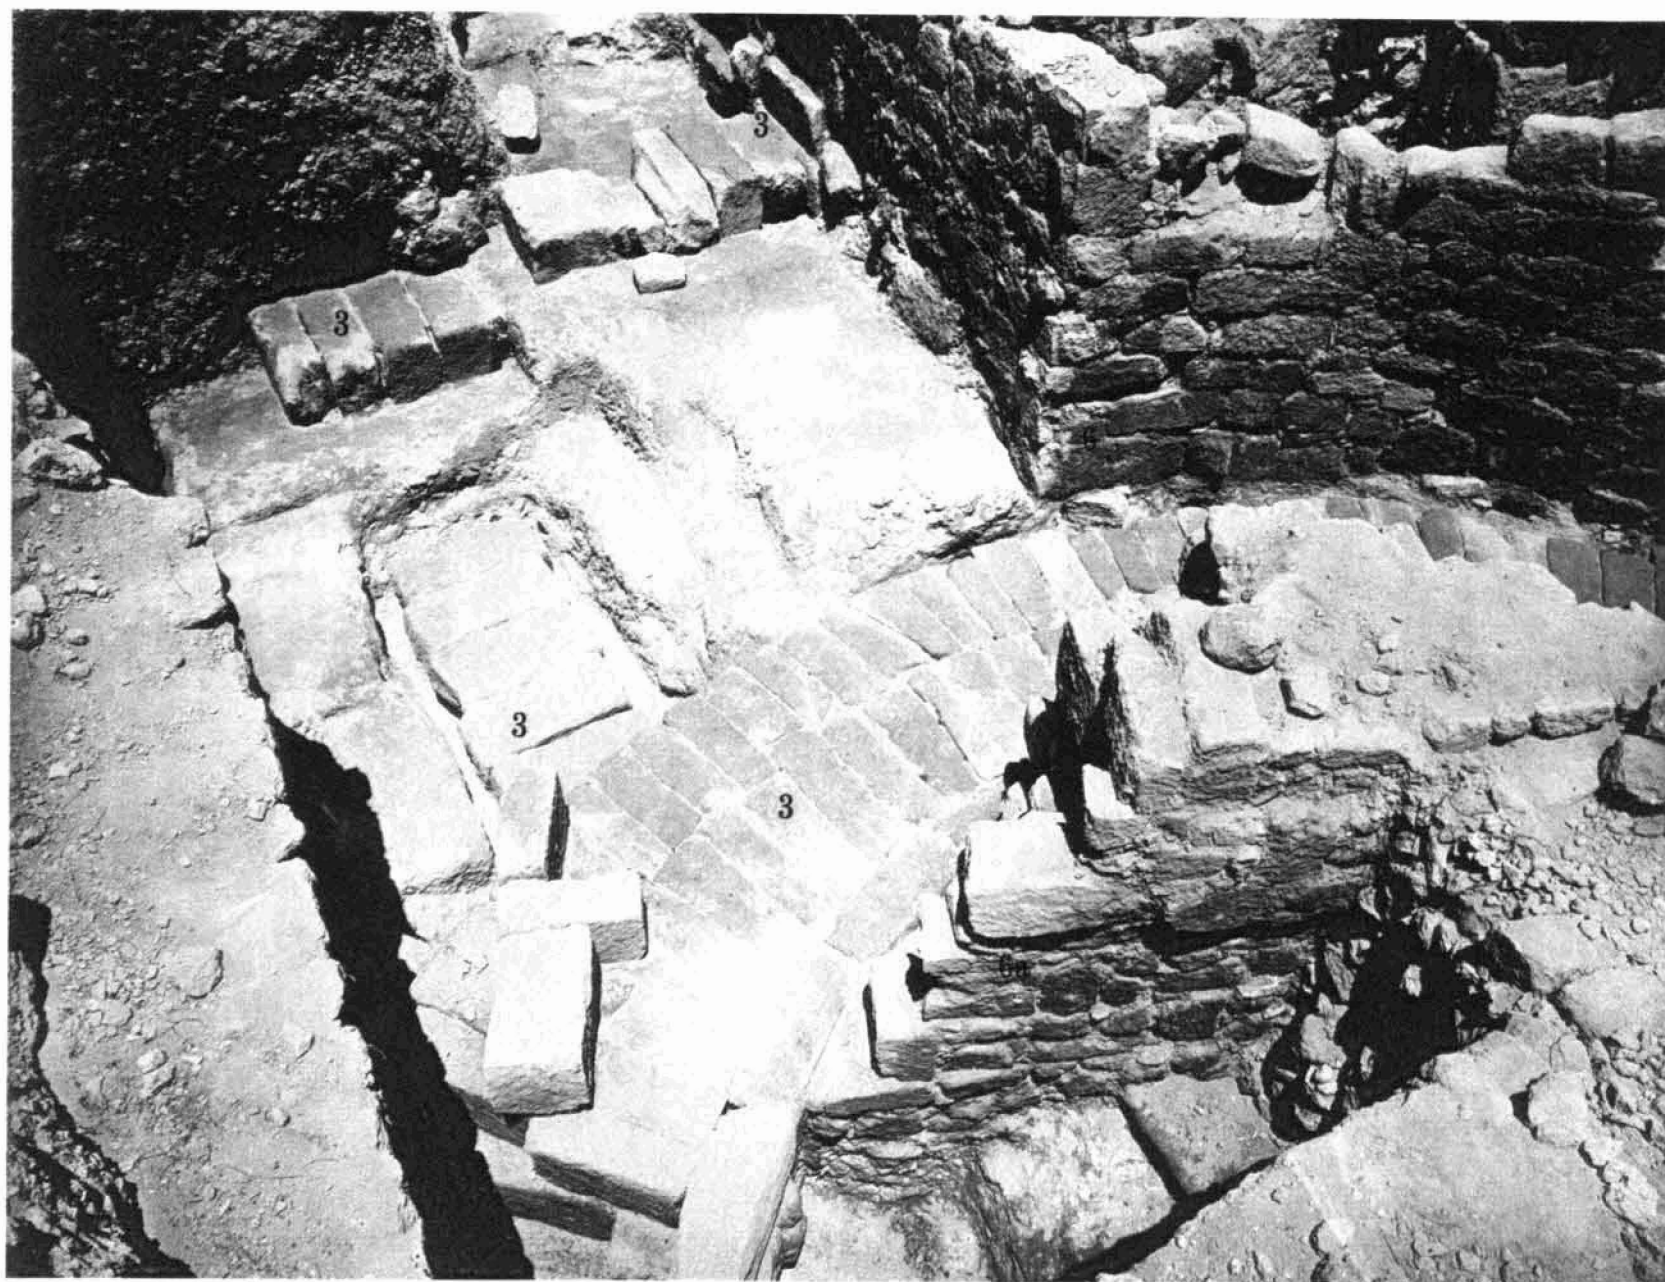
b. STRIP 5. ISRAELITE ROUND TOWER UNDER S. W. BASTION, LOOKING N. N. E. JULY 27, 1910.

- 28. a. Strip 5, reconstructed southwest bastion of the Greek Fort Wall, looking north. July 7, 1910.
- b. Strip 5, Israelite round tower, under southwest bastion, looking north-northeast, down. July 27, 1910.
